Chena River Lakes Project  
Fairbanks, Alaska

*Overview of Tanana River monitoring and  
research studies near Fairbanks, Alaska*

OVERVIEW OF TANANA RIVER MONITORING AND  
RESEARCH STUDIES NEAR FAIRBANKS, ALASKA  
(with Appendices)

Prepared by  
U.S. Army Cold Regions Research and Engineering Laboratory  
Hanover, New Hampshire

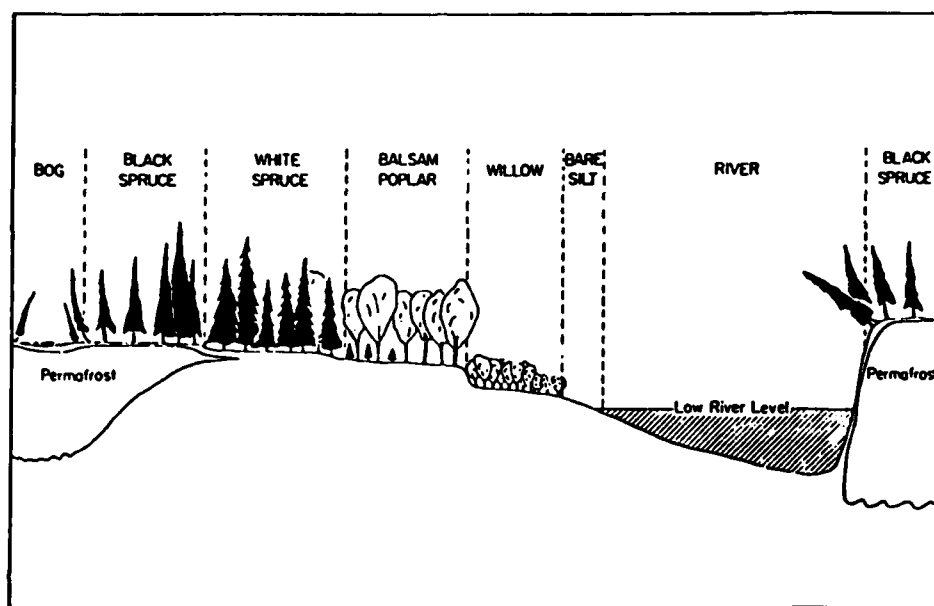
Figure 2.2. Typical permafrost and vegetation succession across river meander in interior Alaska (from Viereck, 1970).

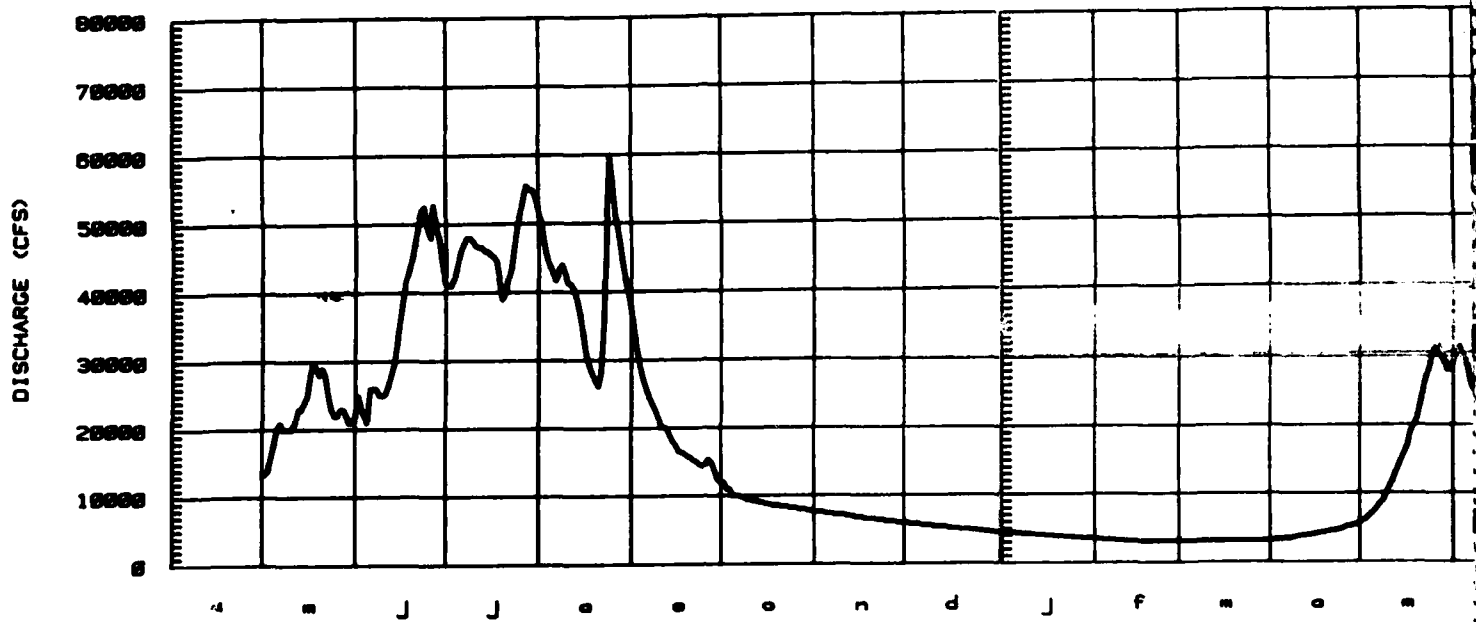
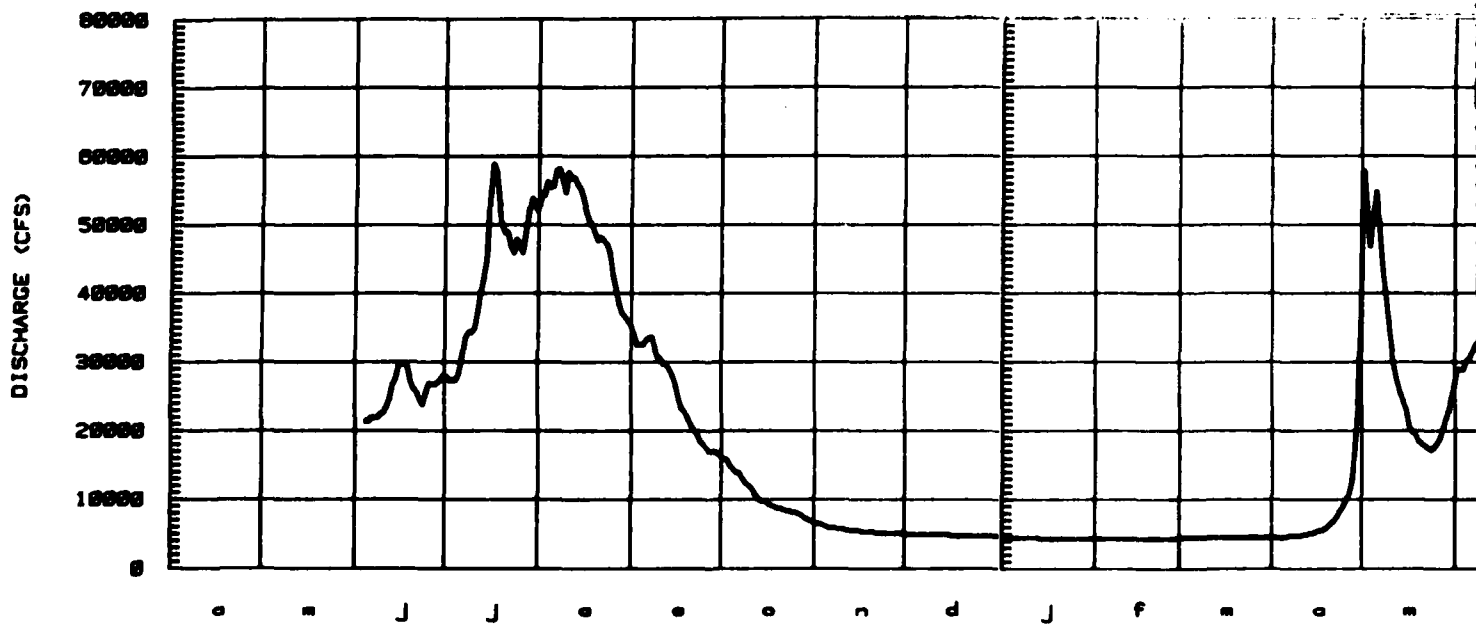
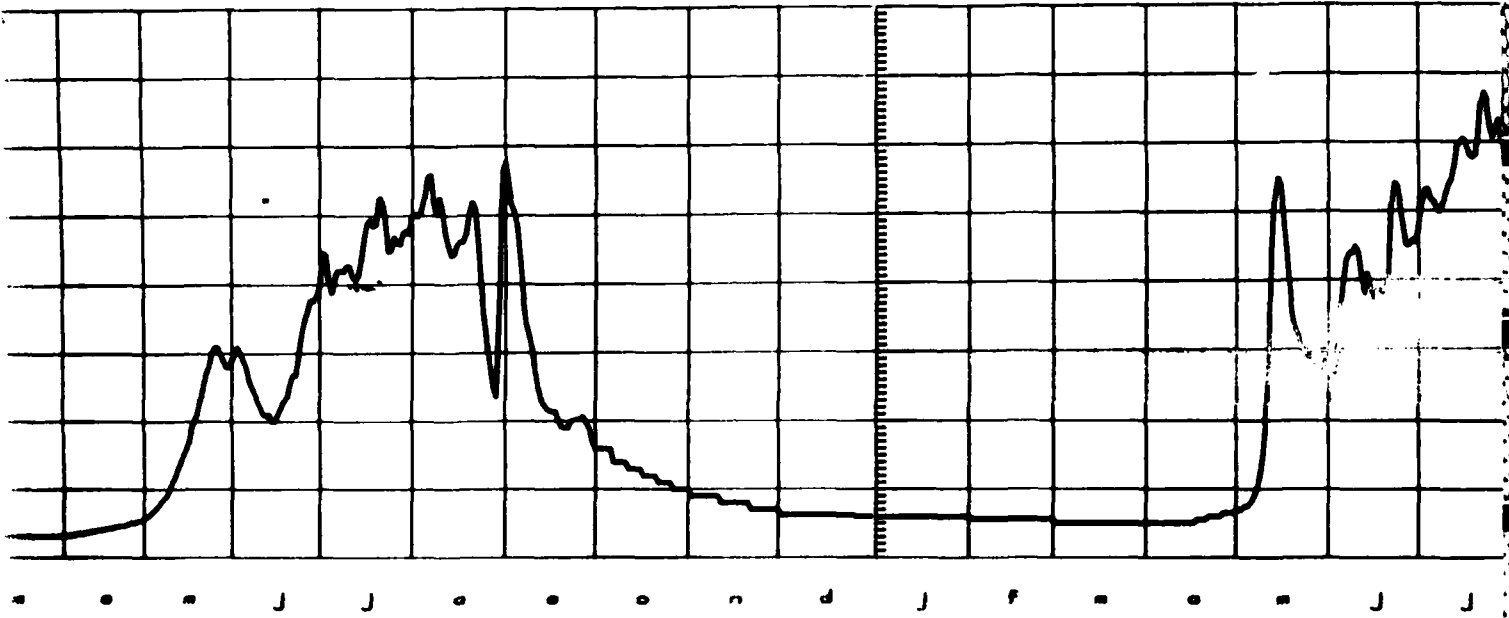
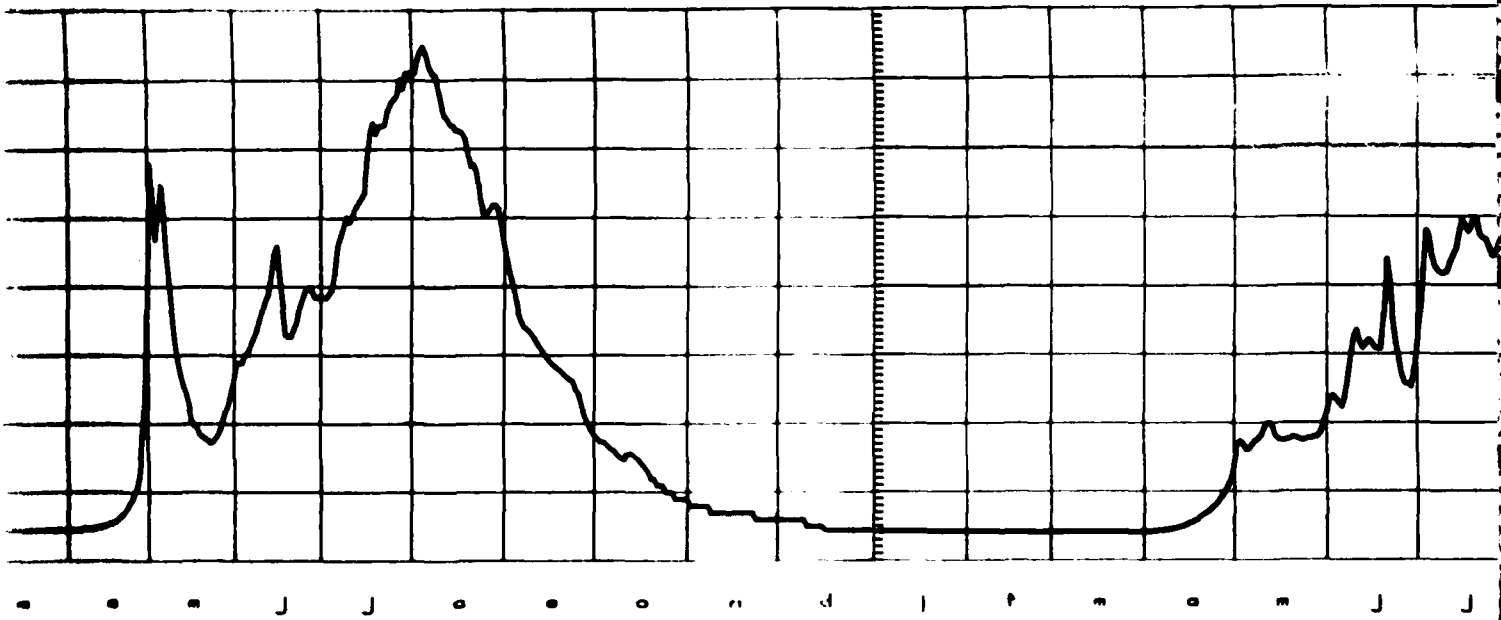
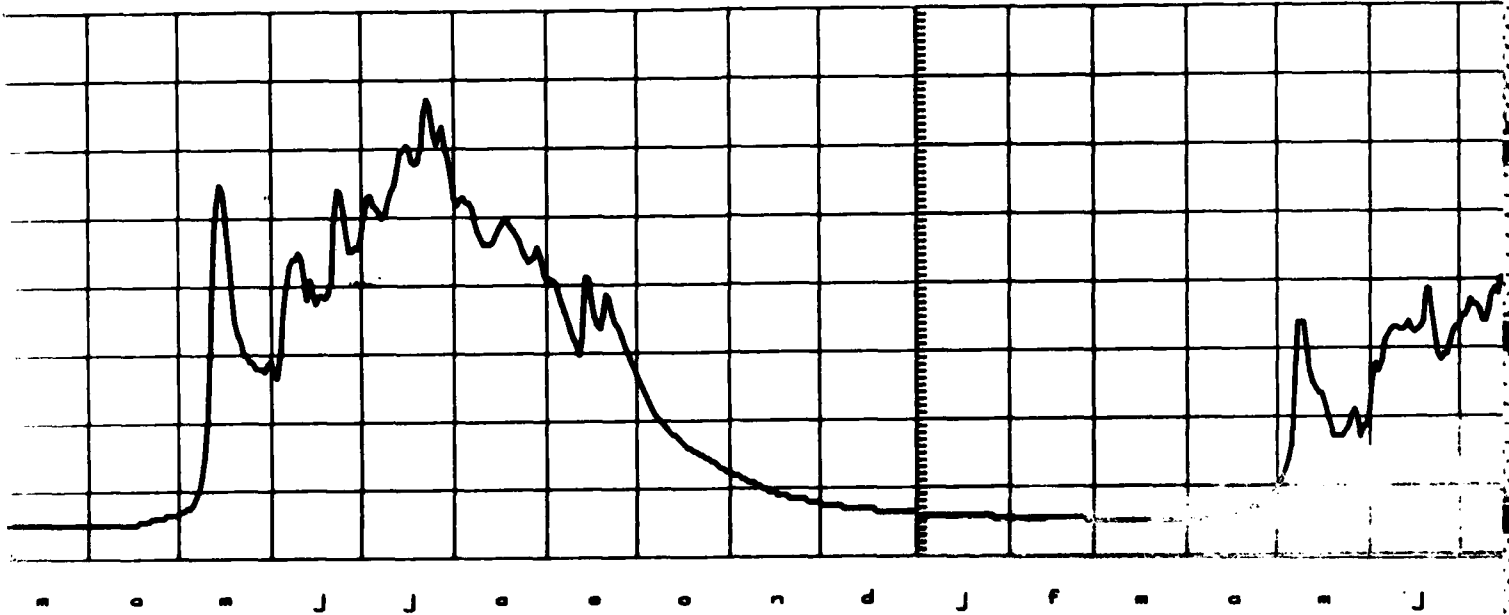
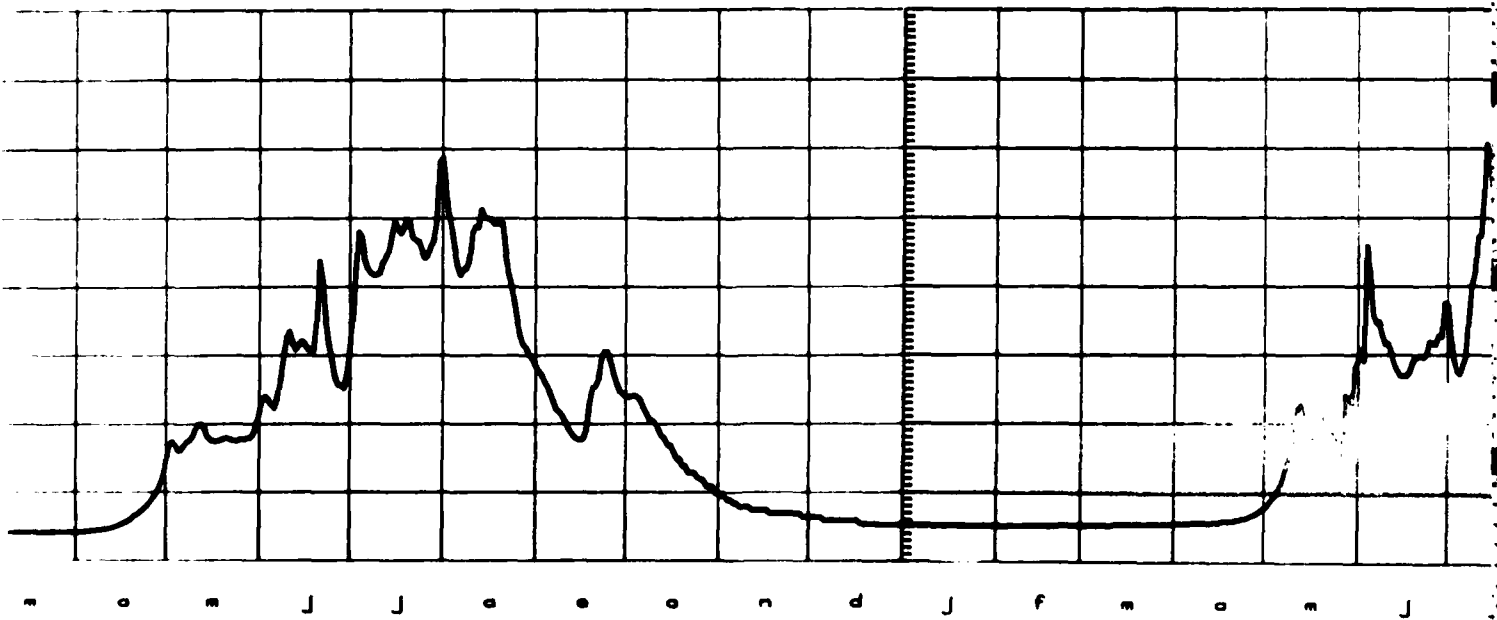
FIGURE 3.1

DISCHARGE HYDROGRAPHS  
TANANA RIVER AT FAIRBANKS  
1973 TO 1982

A 10-year hydrograph of daily discharges (1973-82) at the Fairbanks gauging station is plotted in Figure 3.1.

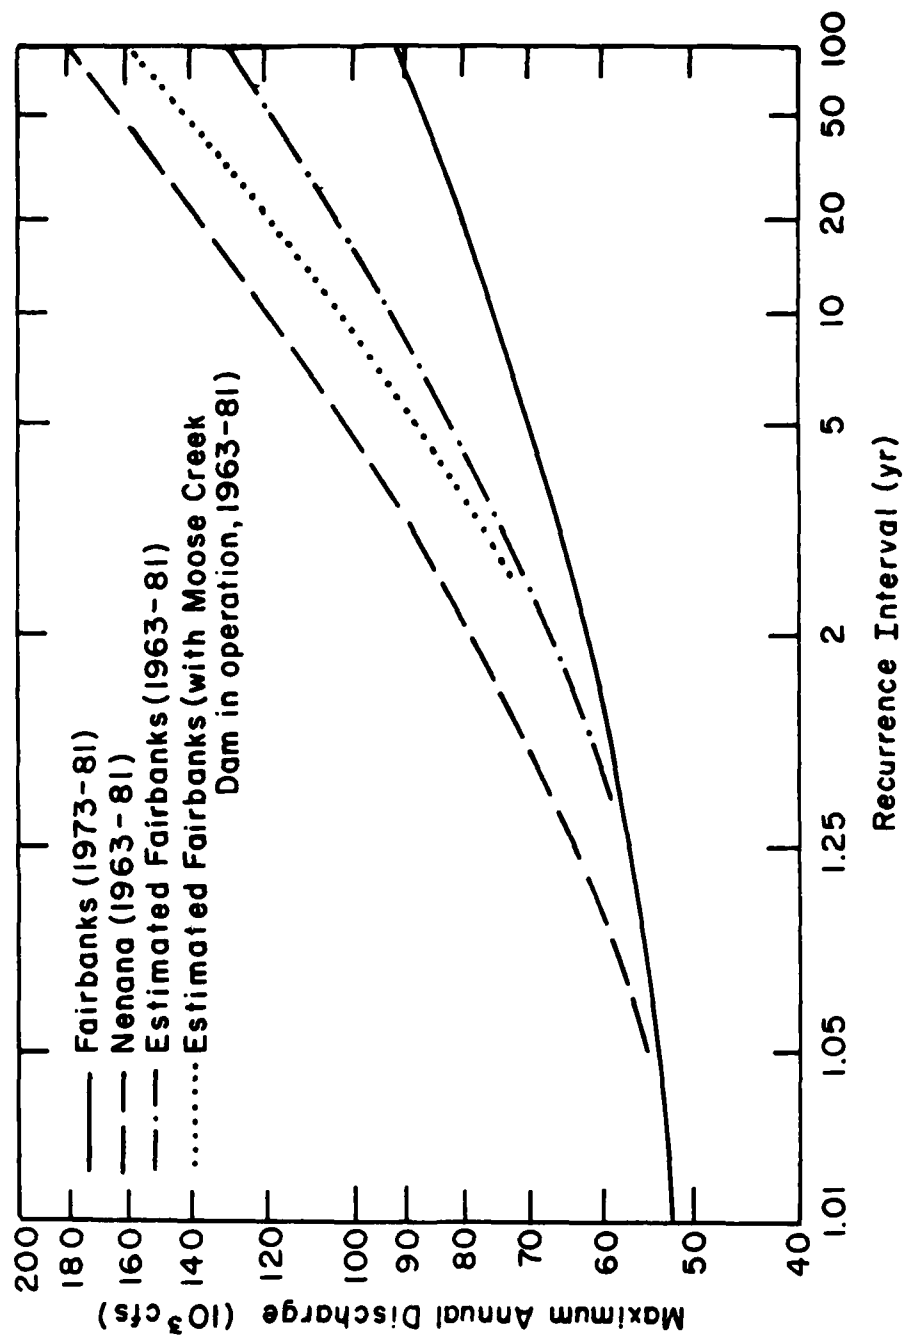
Figure 3.2. Flood frequency curves, Tanana River at Fairbanks and Nenana. (Log-normal fits.)

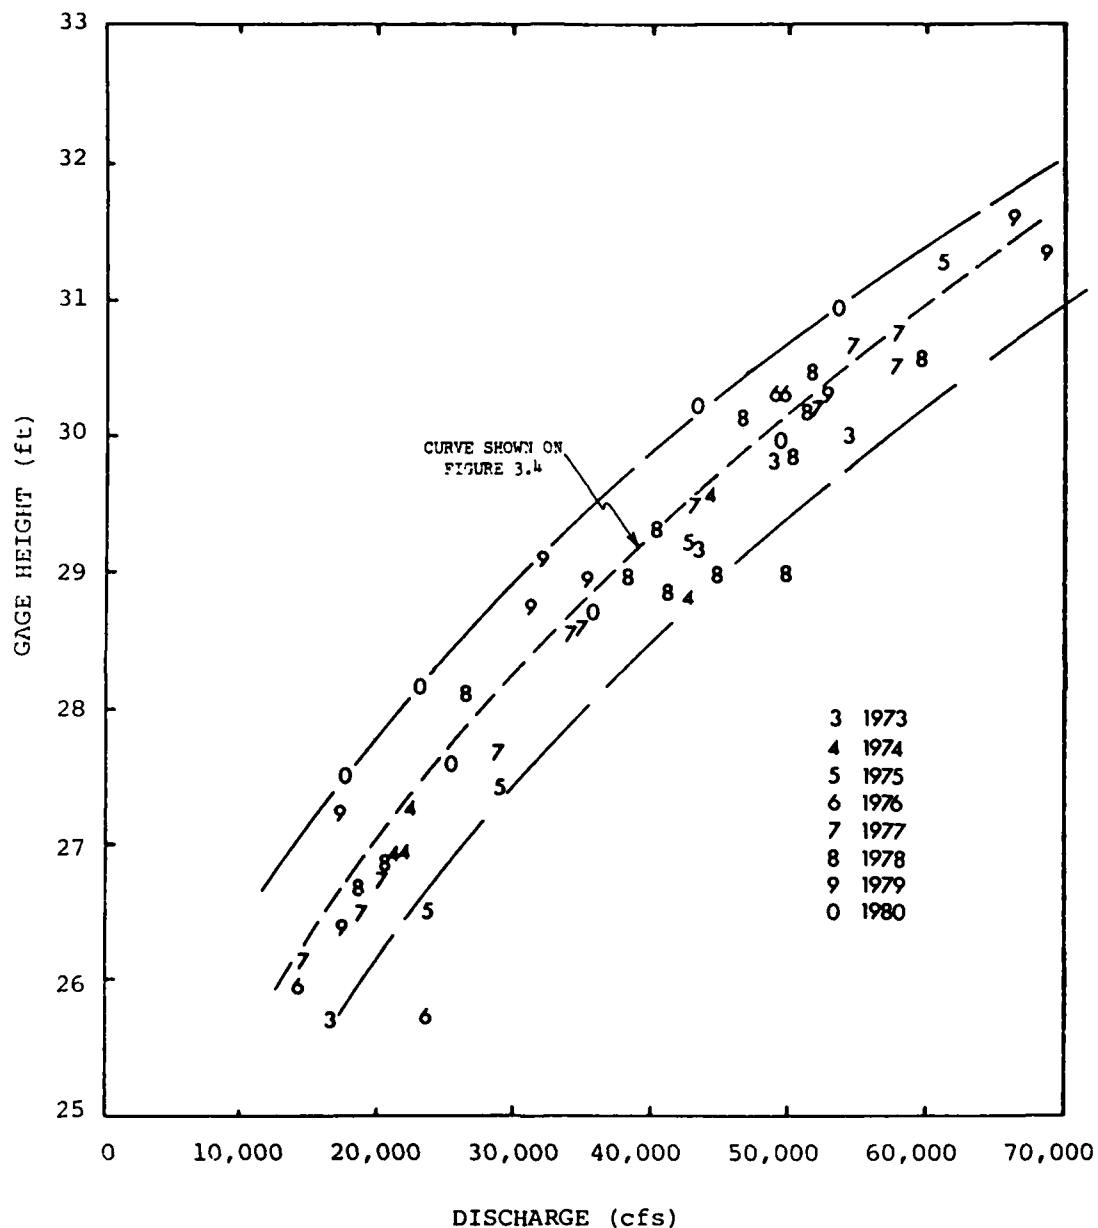
Figure 3.3. Stage-discharge plot, 1973-80, Tanana River at Fairbanks. (Note: g.h. = 0 is 400.0 ft above sea level, discharge actually measured at the cross section GSX2, gauge height actually measured at Fairbanks gauging station.)

In order to estimate cross-sectional properties at a common high discharge of 60,000 cfs, water levels at time of survey were adjusted by means of stage-discharge plots such as shown in Figure 3.3. Similar plots were prepared for other locations using water-level observations as tabulated by USGS for the "T" sites. This approach is open to objection and is admittedly somewhat crude, but is considered justified as a means of examining the average variation in cross-sectional characteristics along the river.

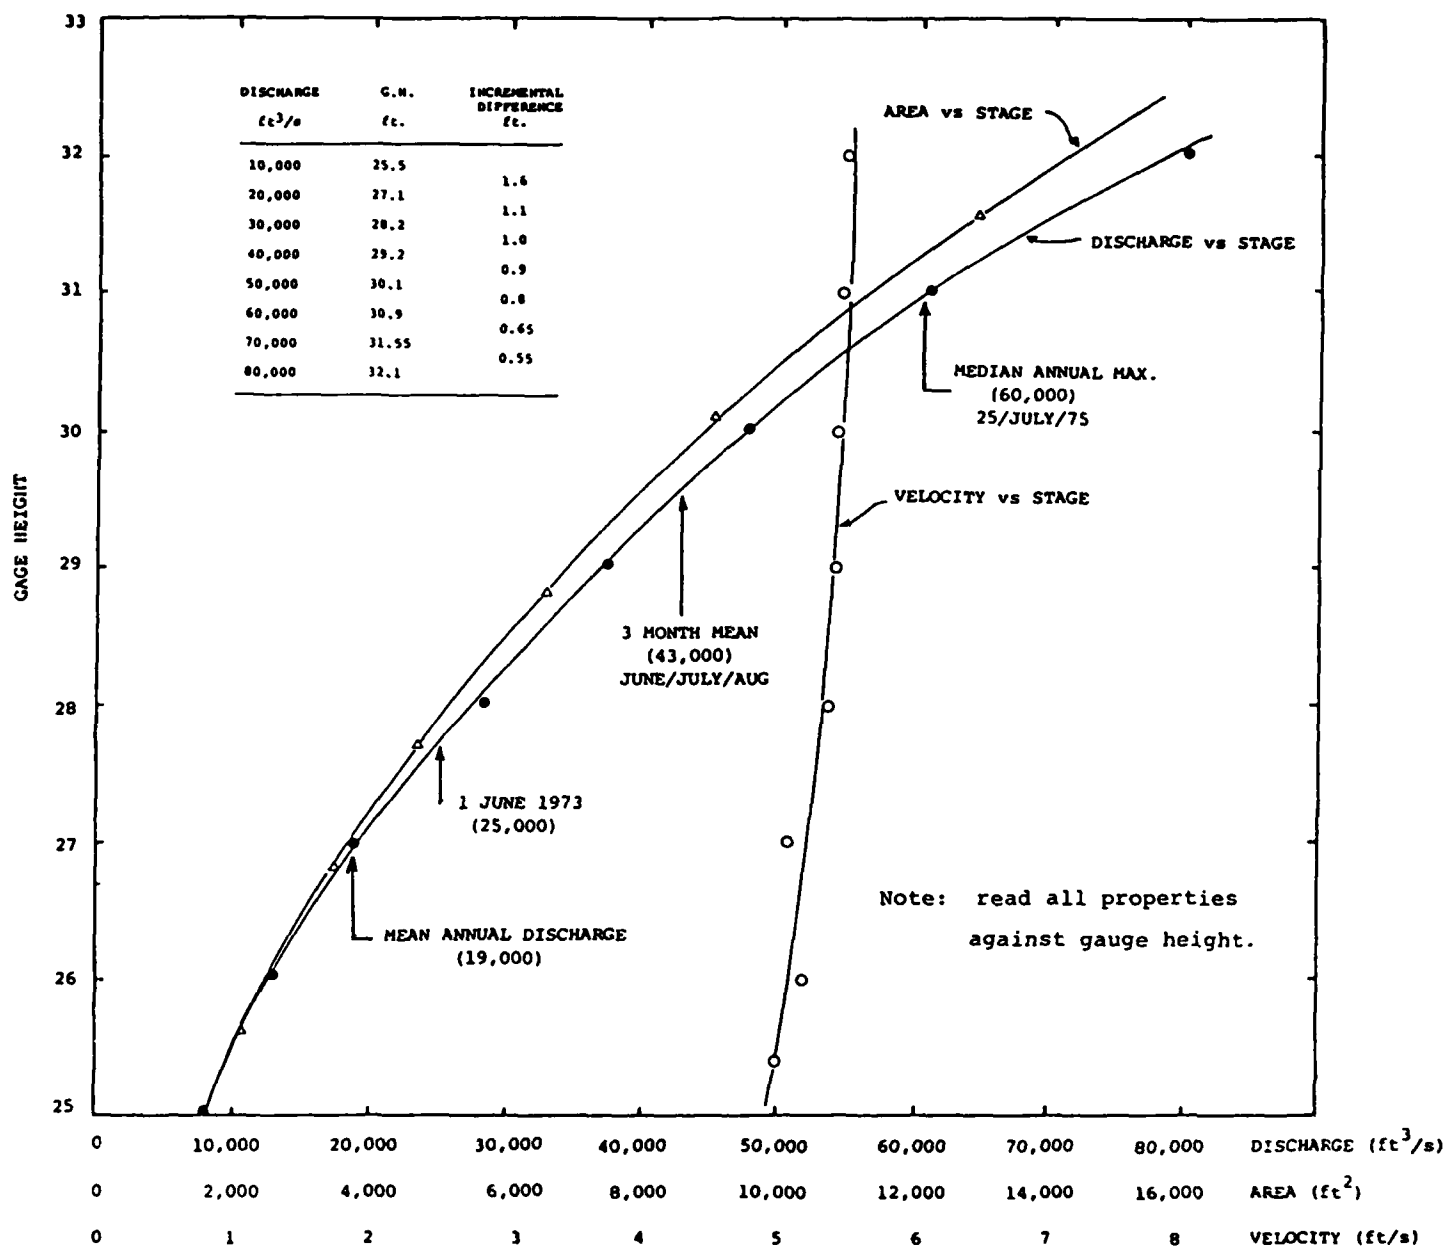
Figure 3.4. Approximate stage-discharge/area/velocity relationships for Tanana River at Fairbanks. (Note: Based on applying mean curve of Figure 3.3 to mean areas at the cross section of Tanana River at Fairbanks [GSX2].)

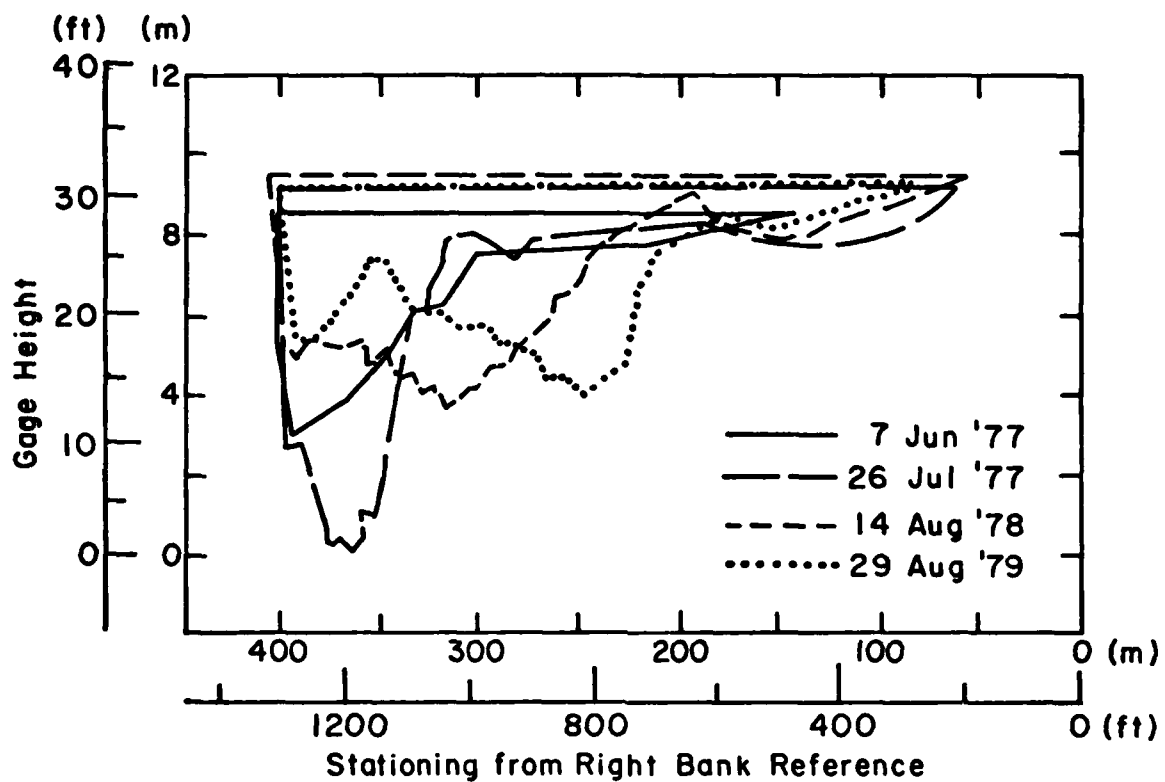
Figure 3.5. Selected changes in the cross section, GSX2, 1977-79.

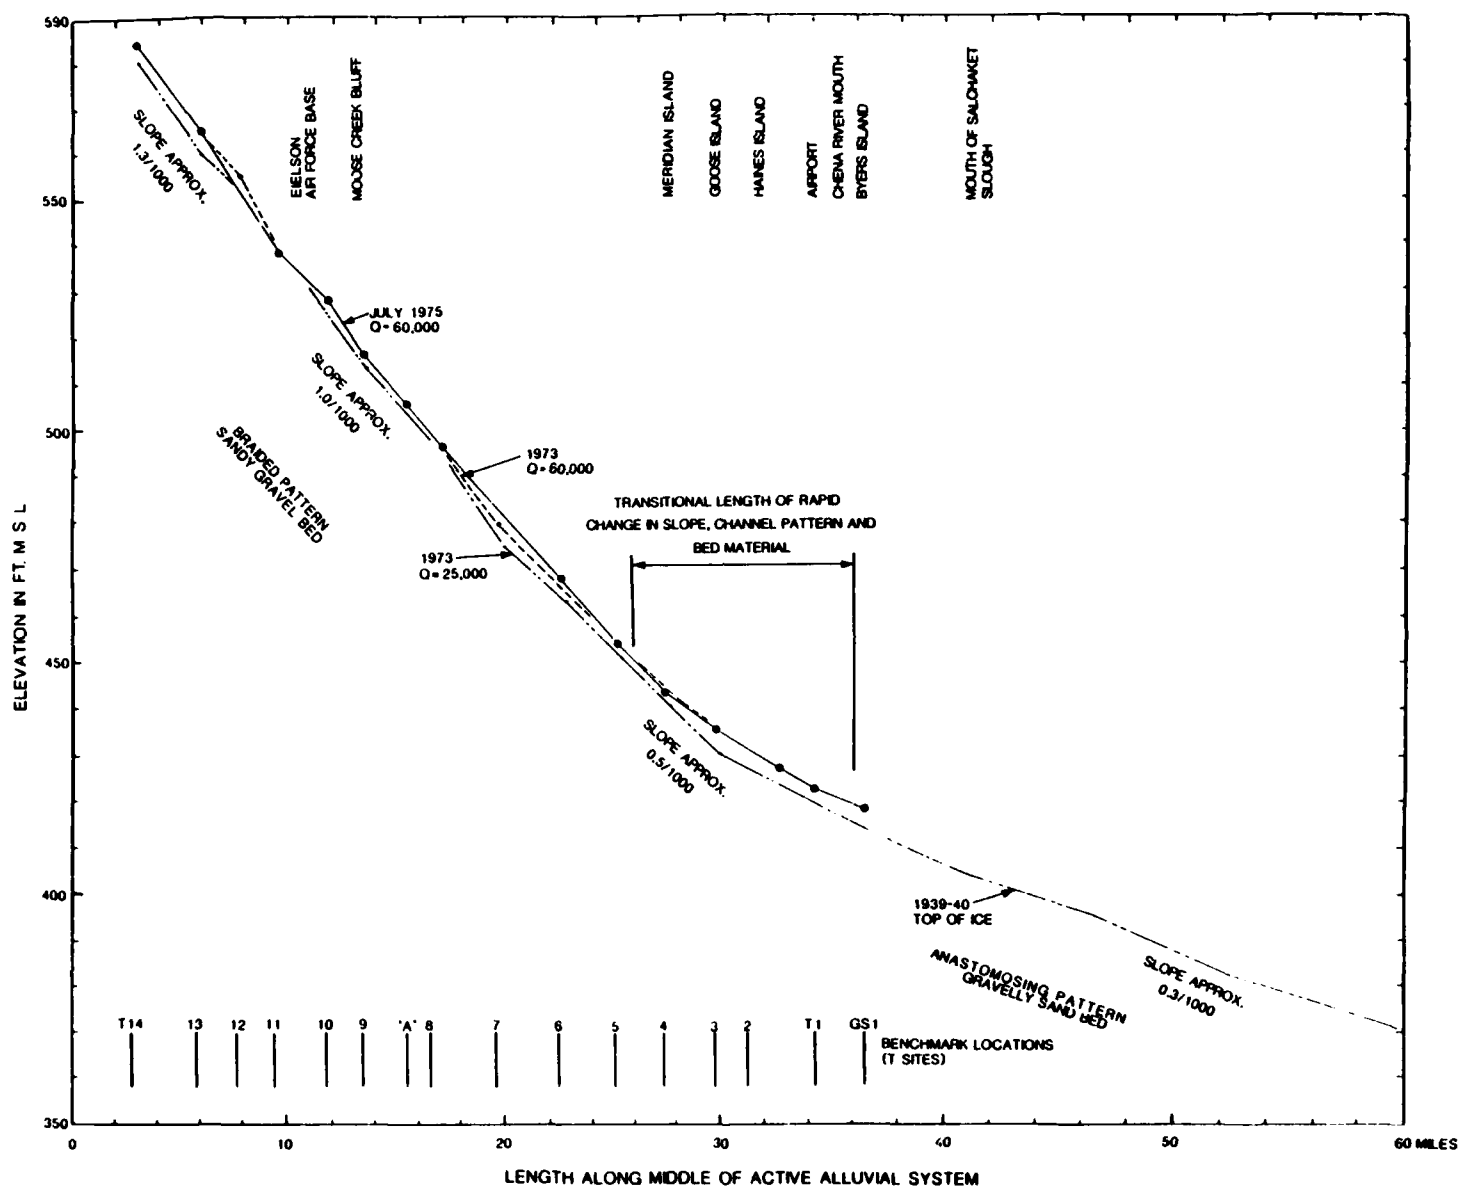
Figure 3.6. River slope profiles.

Figure 3.6 shows a composite river slope profile based on the following data:

The average slope decreases progressively from about 1.3/1000 above Moose Creek Bluff, to about 1.0/1000 at North Pole, to about 0.5/1000 at Fairbanks, to about 0.3/1000 below Byers Island. The most rapid change occurs between Meridian and Byers Islands, where the slope drops in half over a length of only 10 miles. Within this length, the planform of the river changes markedly from a clearly braided pattern above Meridian Island to an anastomosing pattern below Byers Island; the latter consists essentially of a single main channel with irregular meanders plus one or more minor channels or 'sloughs' separated from the main channel by stable islands. The contrast in patterns is shown in Figure 3.7. As will be shown in Part 4, a notable change in bed-material composition also occurs in the vicinity of Byers Island.

Upstream of the Phase III area, most of the available cross-sectional plots are based on low-stage surveys of 1977, and more uncertainty is involved in adjusting water levels to 60,000 cfs, especially as most of the cross sections involve multiple channels. Approximate properties over a length of about 16 miles, extending upstream from cross section 6A to cross section 21 near the USGS (North Pole) gauge T-8, are shown in Table 3.4. It is immediately evident that upstream of cross section 13, located just above Meridian Island, the sections are wider and shallower but not notably different in area: this change corresponds to the change from a transitional to a fully braided channel pattern as indicated on Figure 3.6.

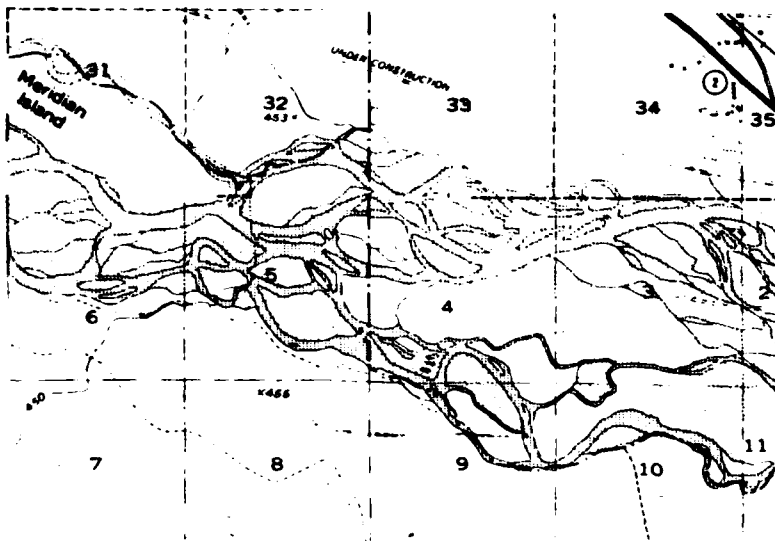
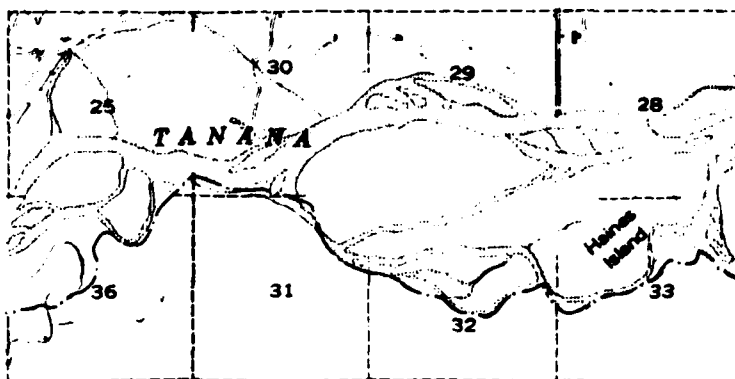
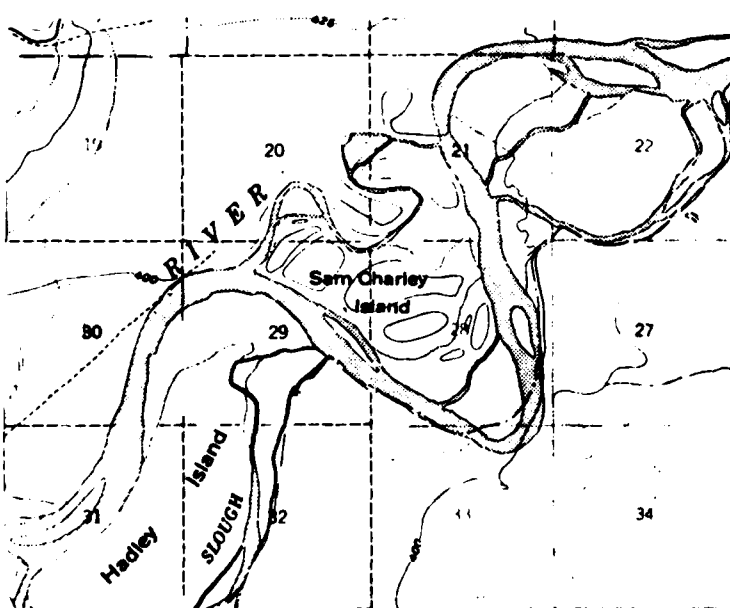
upstream of  
Meridian Island  
slope  $\sim 1/1000$

near Fairbanks  
slope  $\sim 0.5/1000$

below Byers Island  
slope  $\sim 0.3/1000$

Figure 3.7. Typical channel patterns associated with different river slopes.

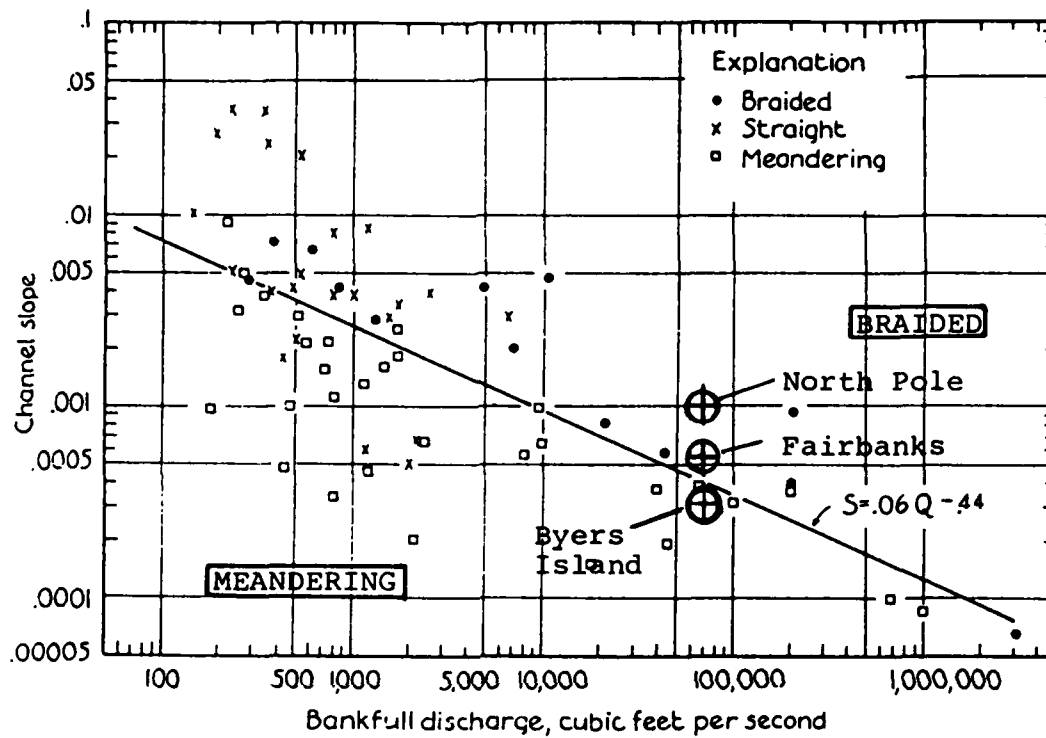
Figure 3.8. Slope-discharge plot distinguishing meandering and braided channels (from Leopold, Wolman and Miller, 1964).

As has been partly shown in previous reports (C of E, 1979; NHC, 1980), the slope/discharge/channel pattern relationships for the Tanana agree remarkably well with a well-known empirical plot by Leopold et al. (1964). This is shown in Figure 3.8 with points for the Tanana superimposed. The Leopold curve discriminating between braided and meandering patterns in terms of slope corresponds to a point between Fairbanks and Byers Island, which is a reasonable representation of the field situation if anastomosing is regarded as a form of meandering.

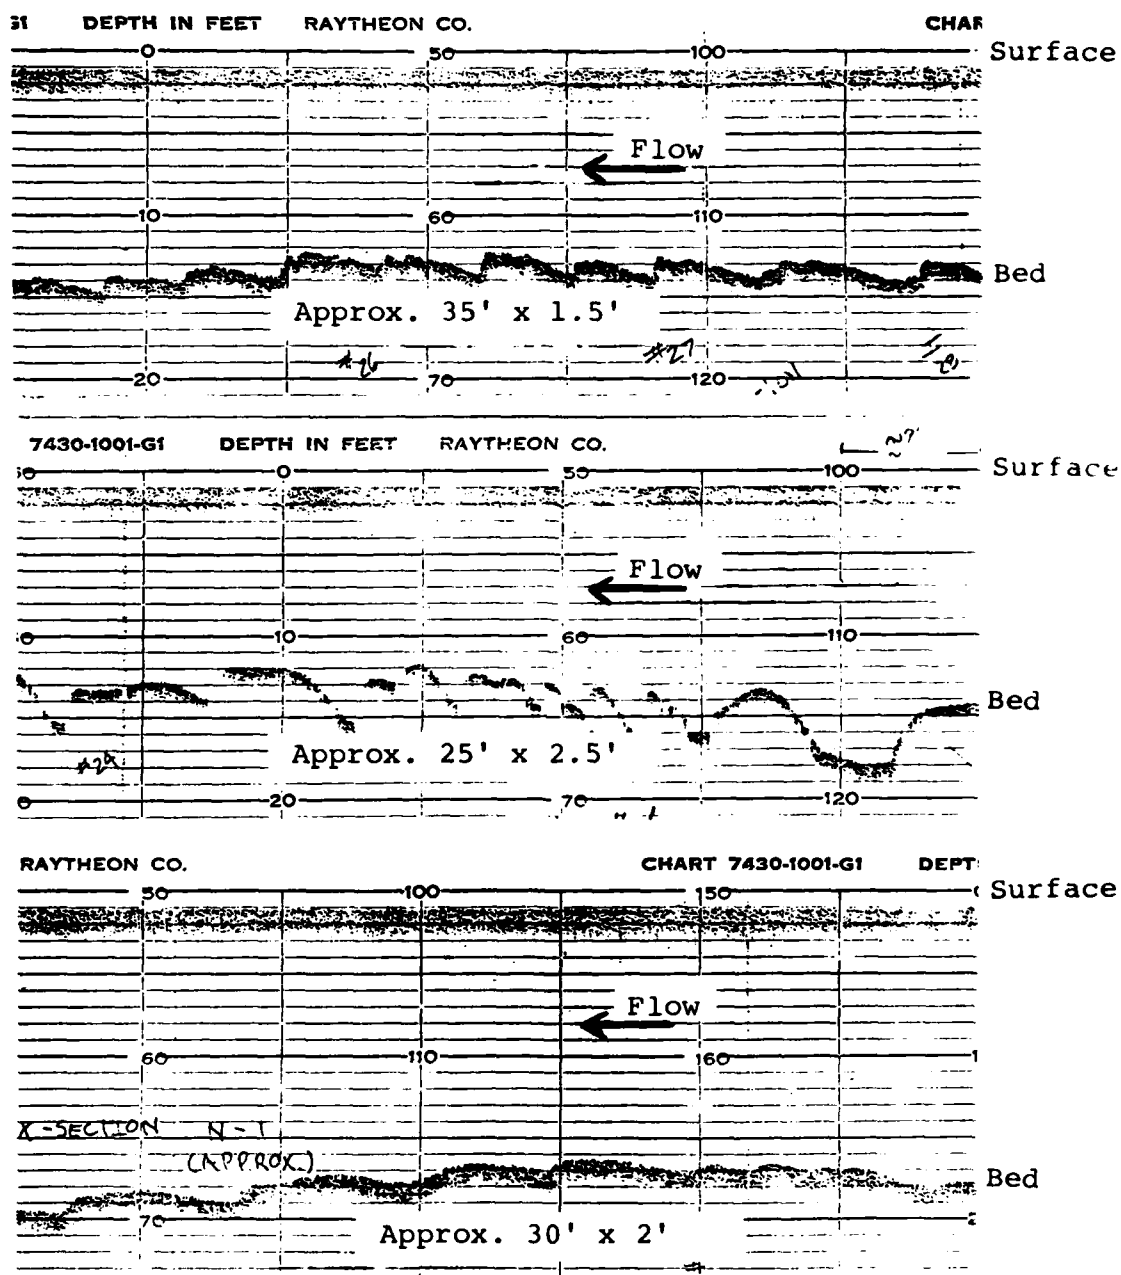
Figure 3.9. Example of bed-forms on longitudinal soundings, Bend 'B,' June 1981.

These  $n$  values appear to be quite low considering the nature of the bed and the channel cross sections. Based on the grain roughness of the bed gravel alone, a value of 0.020 or greater can be estimated. Considering bed-forms and the high degree of irregularity in channel cross-sections and planform, a greater excess over grain roughness might be expected. With regard to bed-forms, longitudinal echo-sounding profiles run on 23 June 1981 at a flow of about 31,000 cfs around the right-hand bend (B) upstream of the Chena mouth indicated a variety of bed configurations ranging from flat bed to waveforms about 50 ft long x 2 ft high (Figure 3.9). It may be that these waveforms denote mainly areas of exposed sand and that their roughness is not much greater than that of gravel areas. Galay (1967) has reported quite similar bed-forms in a

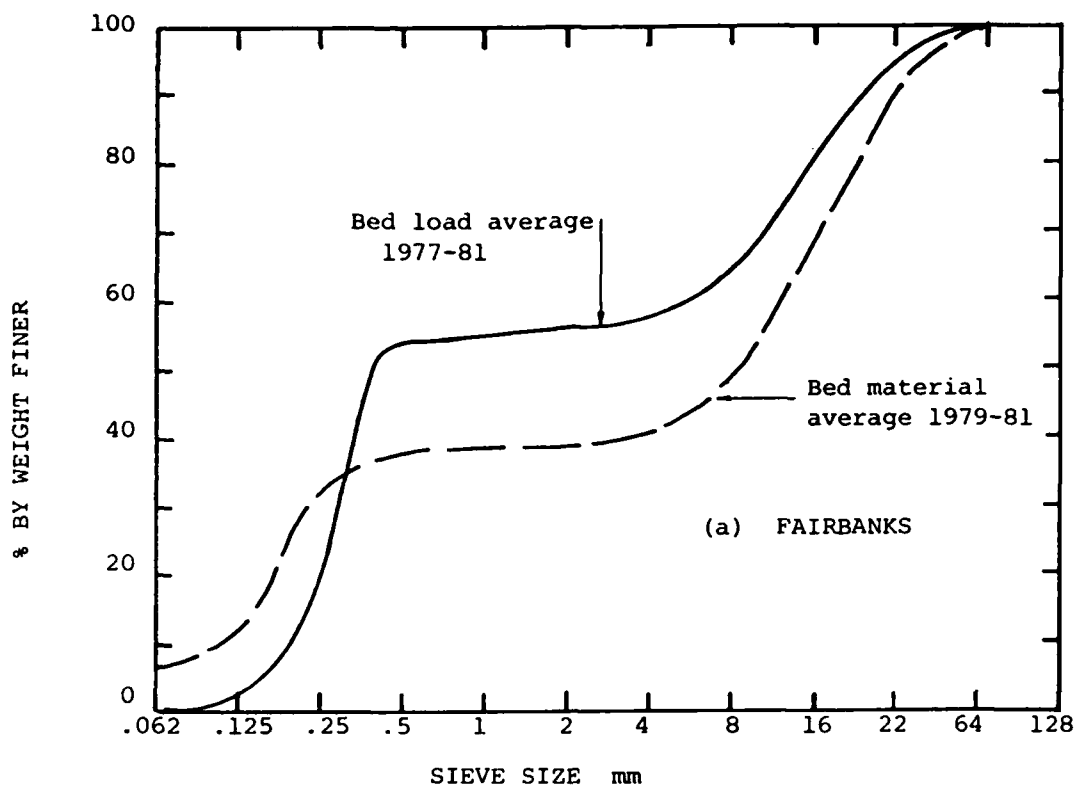
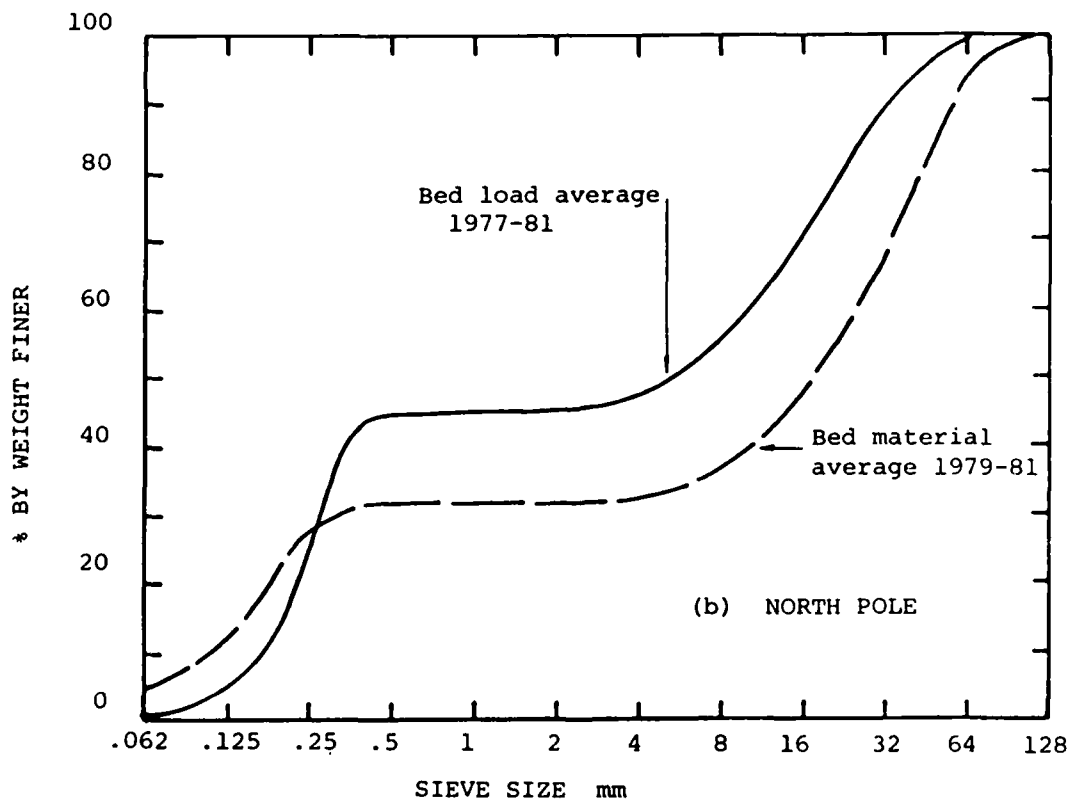
FIGURE 4.1 Composite size distributions for bed material in place and bed load at (a) Fairbanks and (b) North Pole.

Tables 4.1 and 4.2 show summary data for bed-material size distributions at Fairbanks and North Pole respectively for the period 1979-81, both as averages for each year and as averages for the period. At Fairbanks, data are for the main channel; at North Pole, they are averages of north and south channels. Tables 4.3 and 4.4 show corresponding transport-weighted bed-load size distributions for the period 1977-81. The period averages for these four tables (last column in each table) are plotted in Figure 4.1.

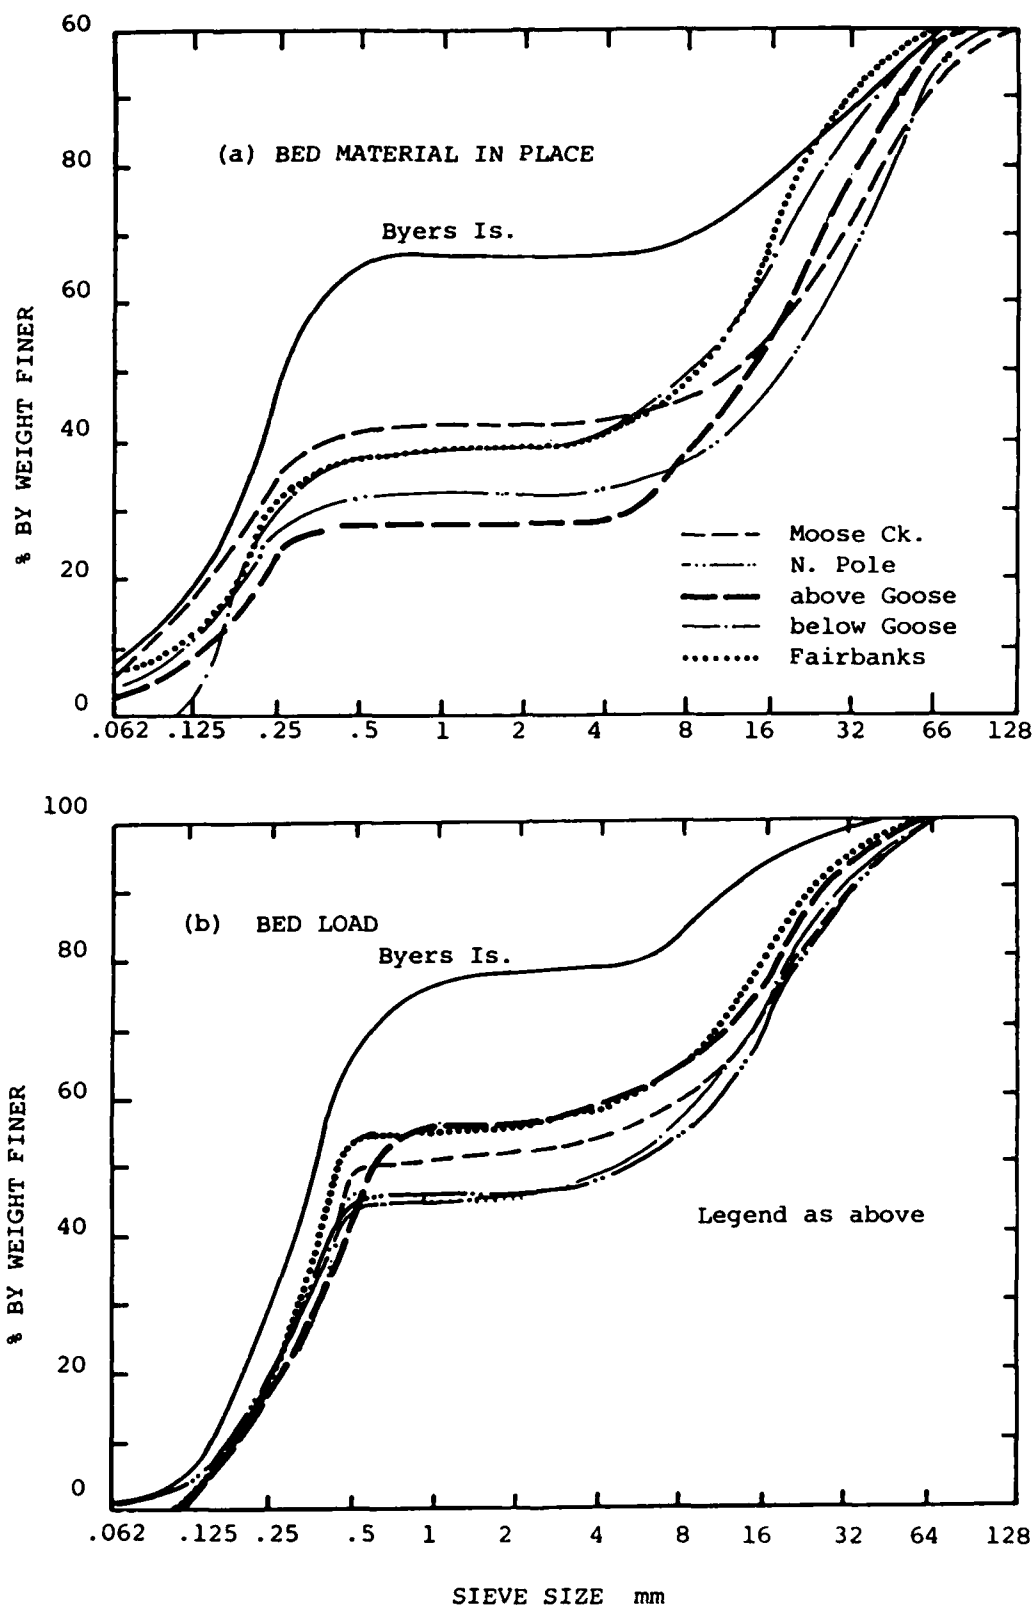
FIGURE 4.2 Comparative size distributions at all sites for (a) bed material and (b) bed load.

Bed material: samples at 15 m intervals and top 20 cm of active width, Sept. 1979, July 1980, Aug. 1981.

Bed load: samples at 15 m intervals, duration 30 seconds, 1977 through 1981.

Tables 4.5 and 4.6 show summary data averaged for 1980-81 for the additional four sediment stations instituted in 1980. These distributions are compared with the Fairbanks and North Pole data in Figure 4.2. Key statistics down-river are compared in Table 4.7.

Based on period averages as plotted in Figure 4.2.

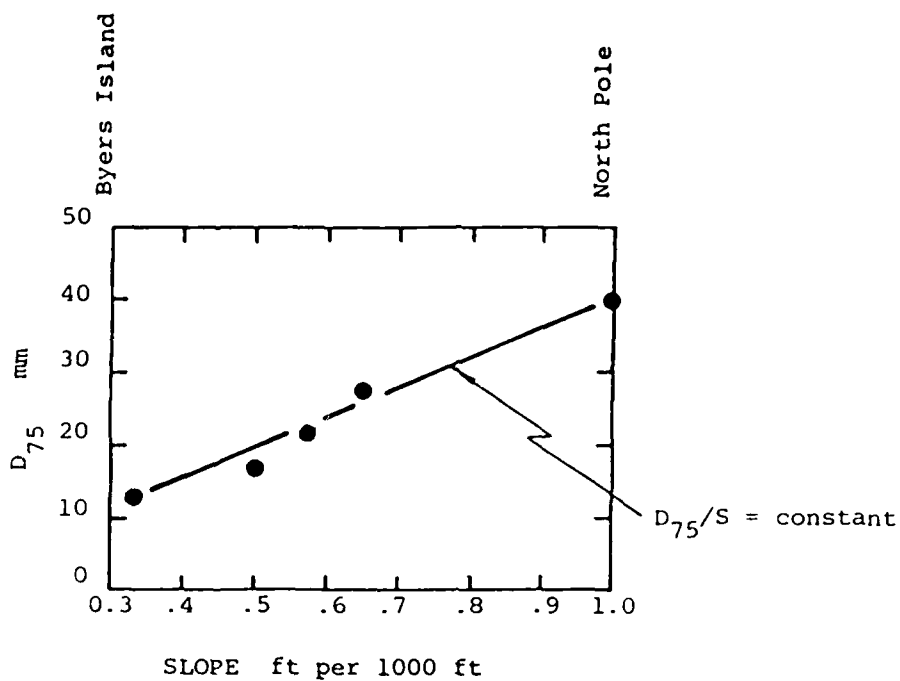
Figure 4.3. Plot of D<sub>75</sub> bed-material sizes vs river slope.

between  $D_{75}$  and slope. Similar empirical findings are reported by Sundborg (1956) and Scheidegger (1961).

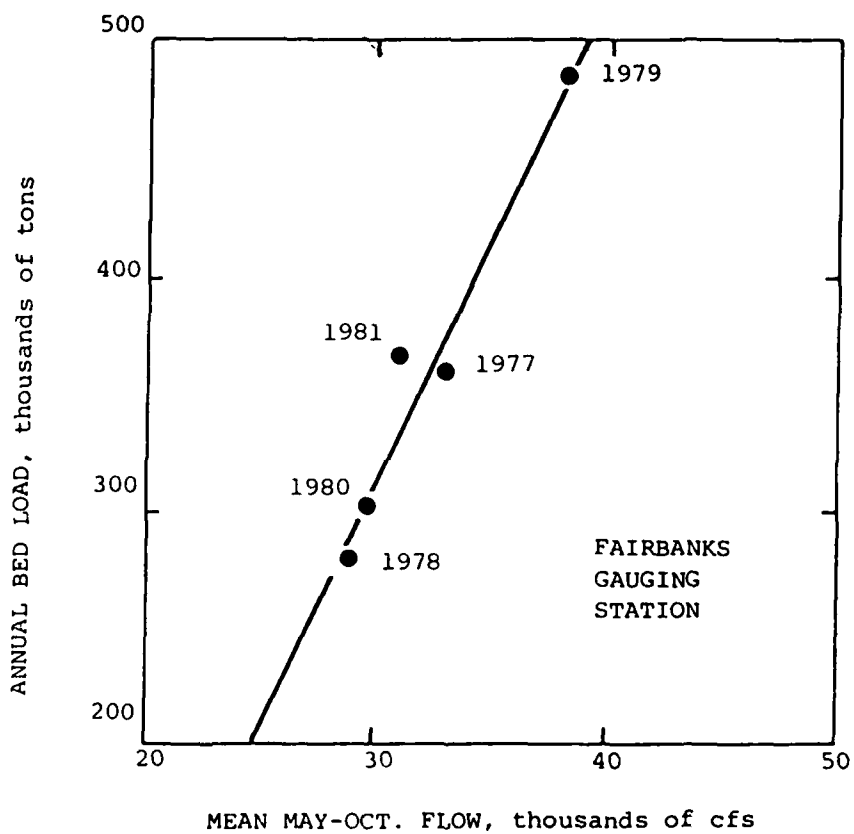
Figure 4.4. Annual bed load vs mean May-October flows, 1977-81.
